MARINE APPRAISAL

FILE NUMBER: 13123N
AT THE REQUEST OF

Date: April 5th, 2013

: Mako 2100 Bay Shark

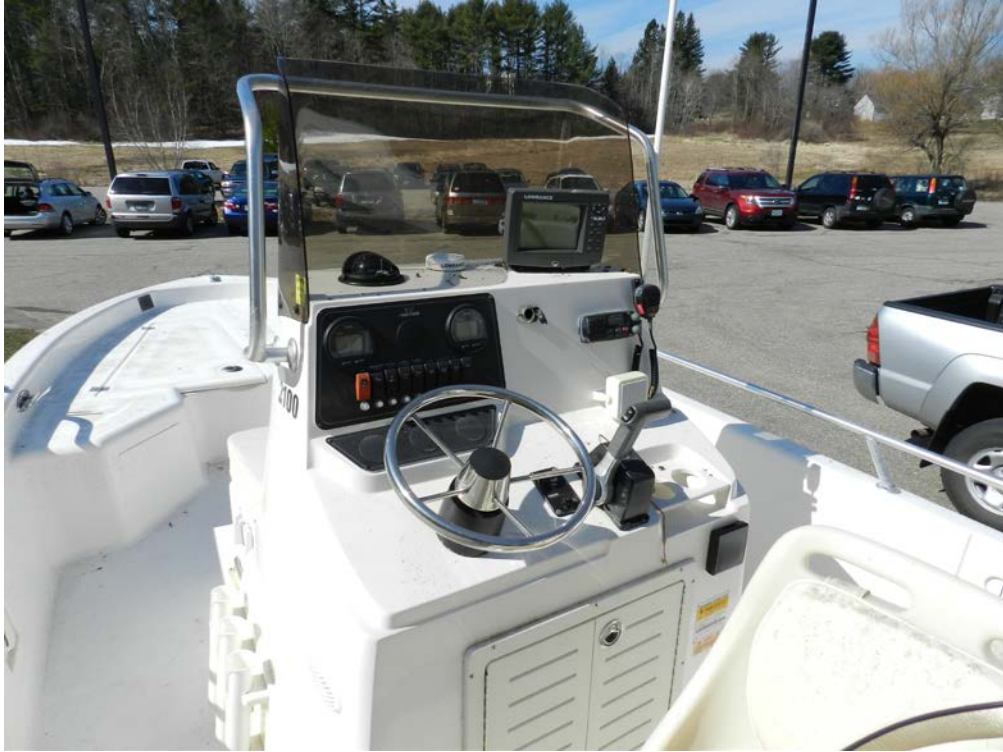
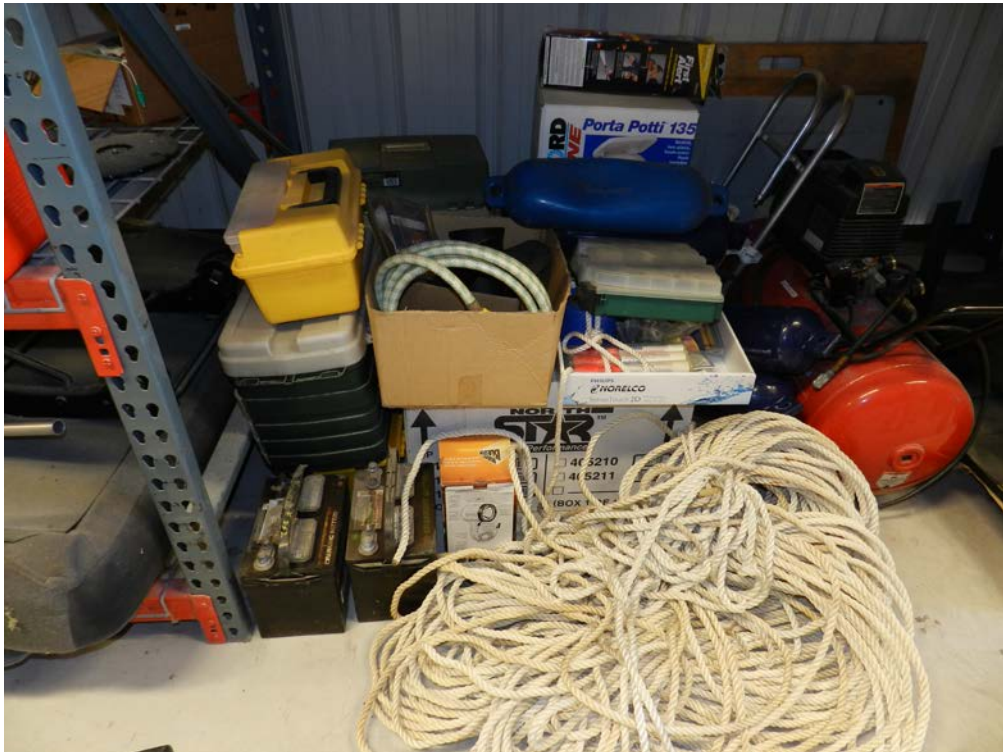
Fishing gear, spares, lines etc
